C452-C552-C652 BLACK UI CHIP REPLACEMENT PROCEDURE.

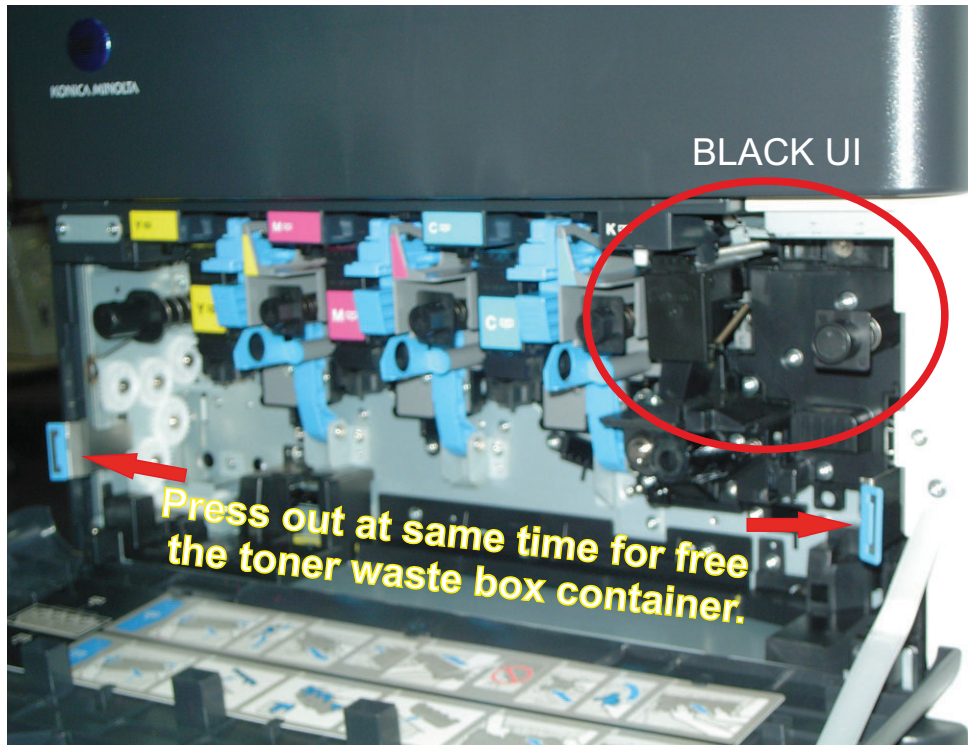
1 . Open the front door and take out the waste toner box by pressing on the directions that the arrows shows on photo, and display the black UI, witch is located the firts one starting to count from the right, it is the bigger one.

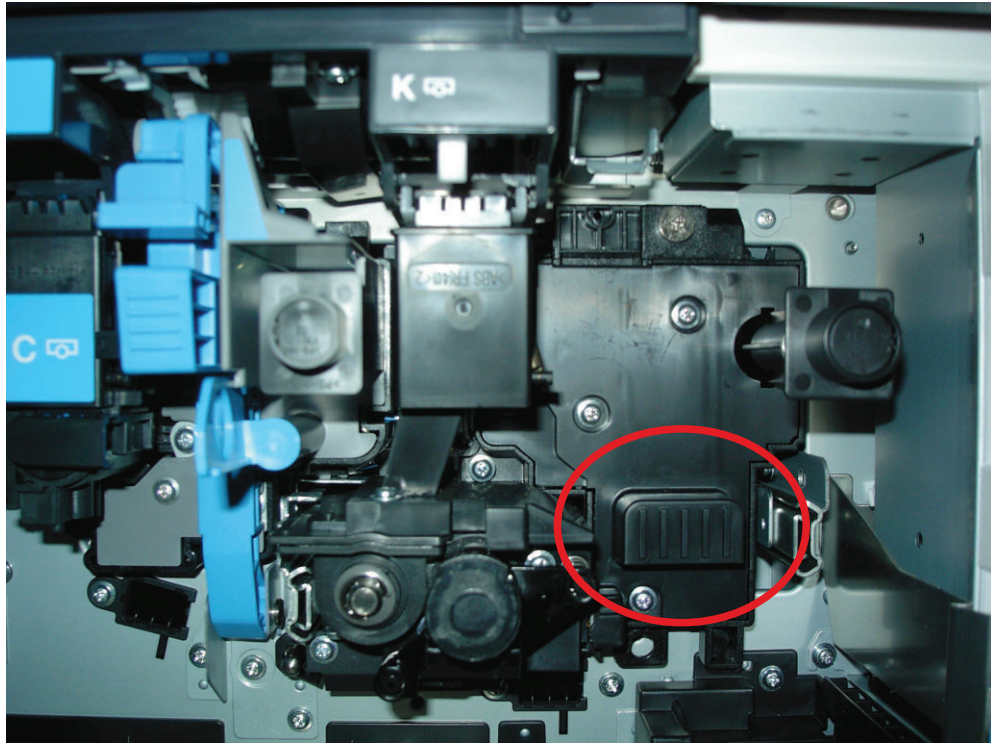
3. Next step is slide the image unit out by the holder, till the end.

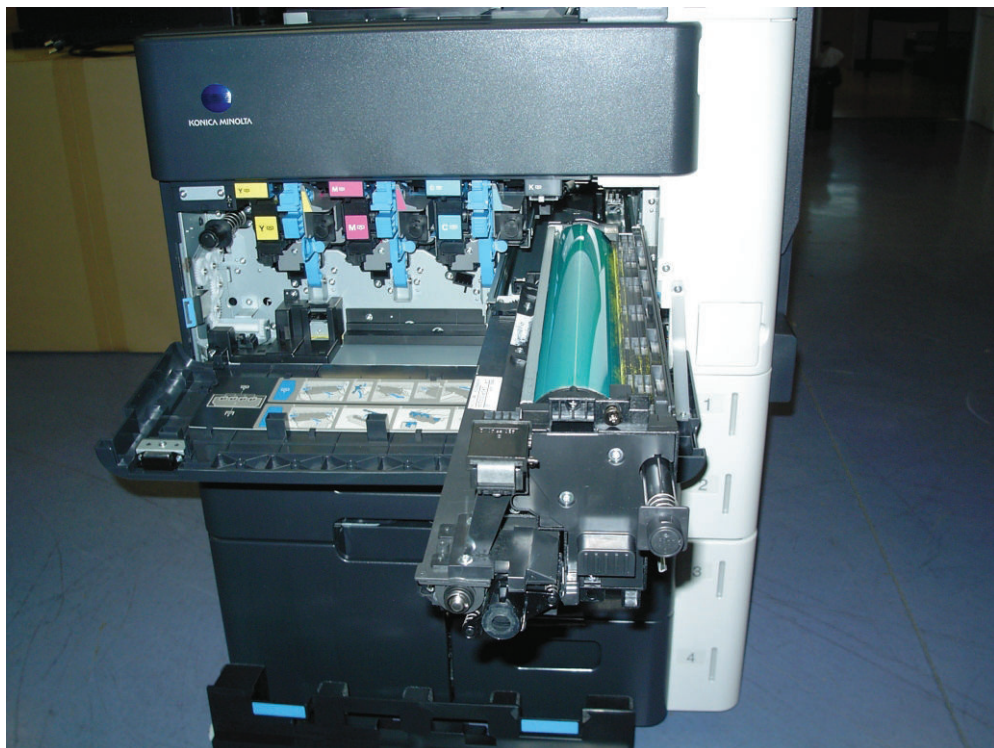
4. Once out, it cannot drop, guides are holding the kit, take easy.

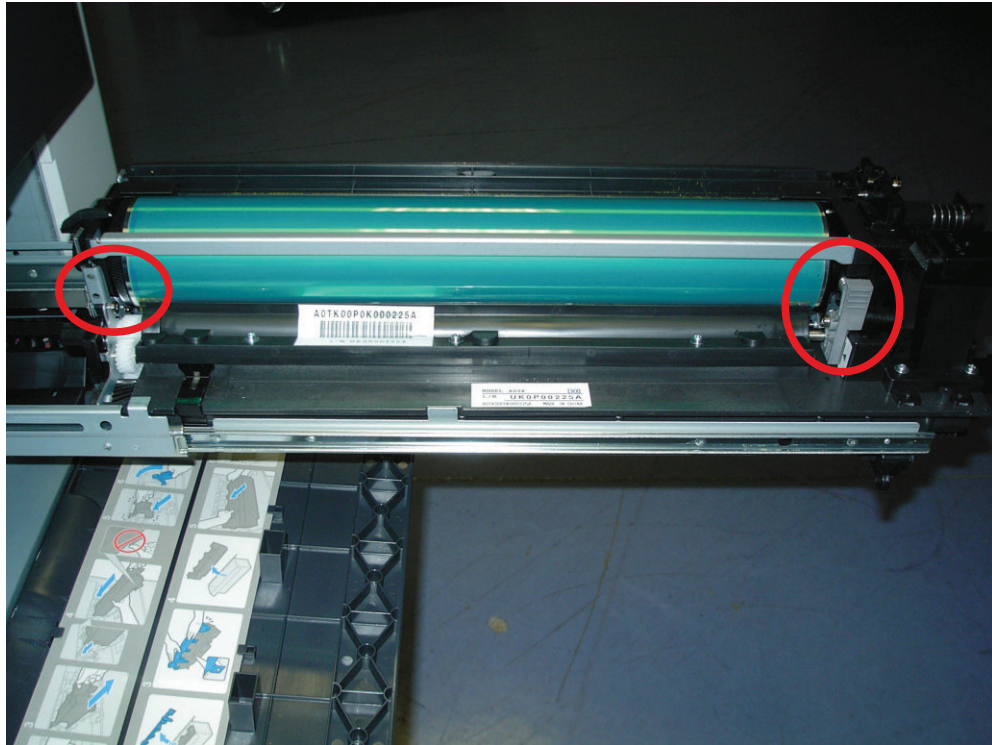
5. Now we have to separate the drum unit from the developing unit, it is easy to do but please be very careful not to damage the OPC surface of the drum (suggested action to cover it). Look at the direction of the photo and with the two hands at the same time take out the drum while pressing with your fingers. Note that the drum unit is not left, just lift it.

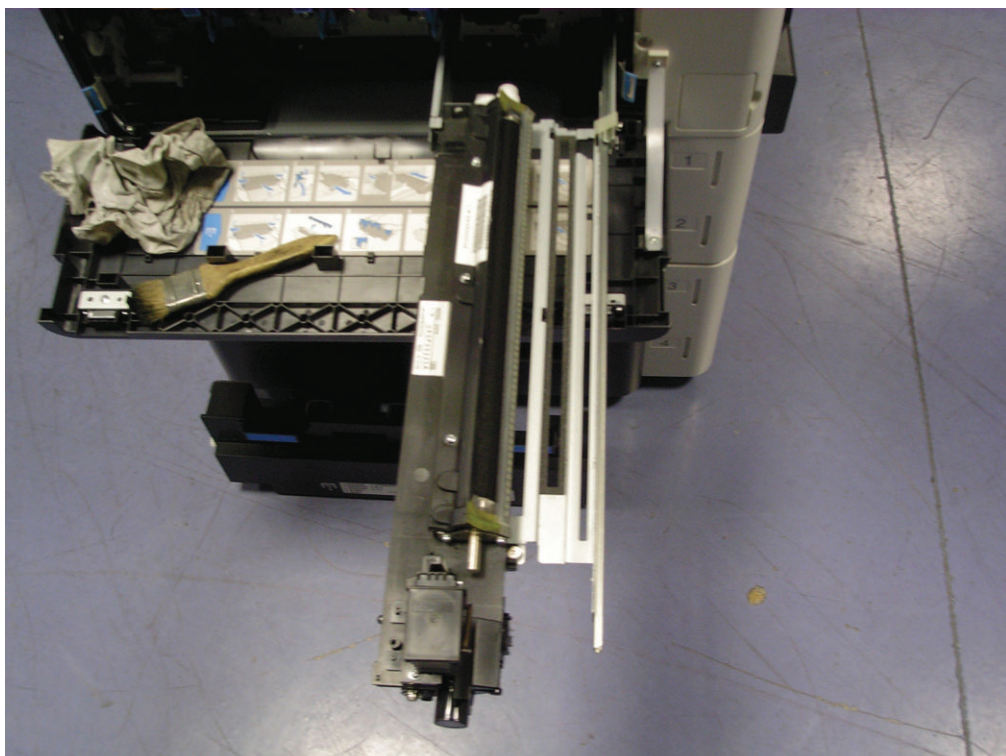
6. Once the drum unit is out, only the developer unit will be hanging on the rails, as shown in the photo.

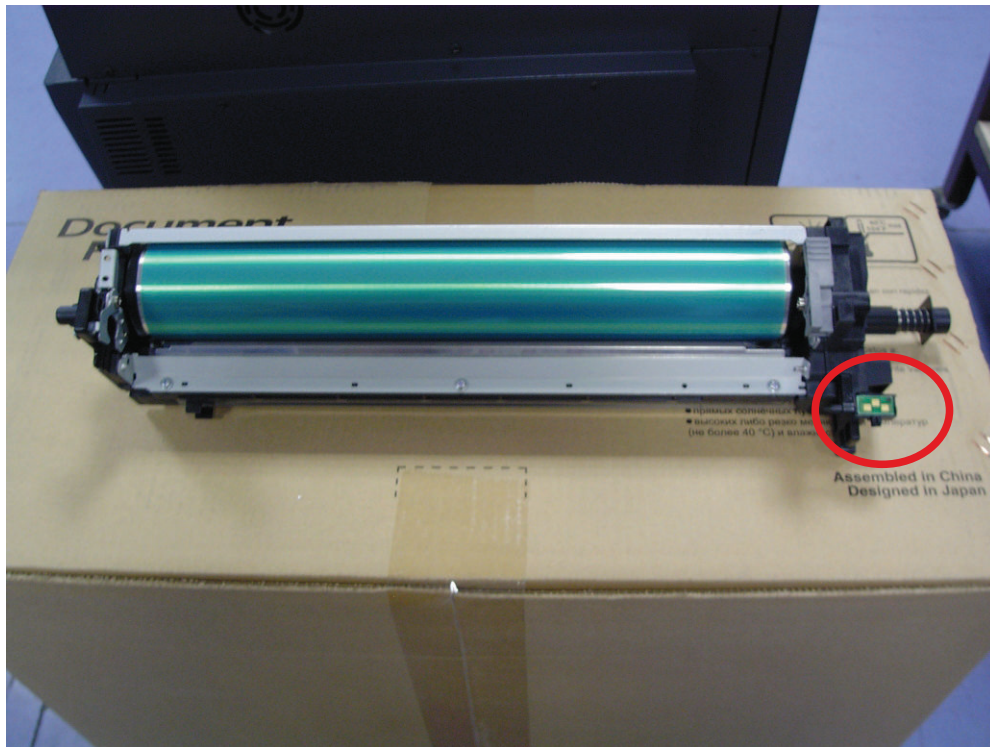
7. Locate the chip on the drum unit and replace for our new chip.

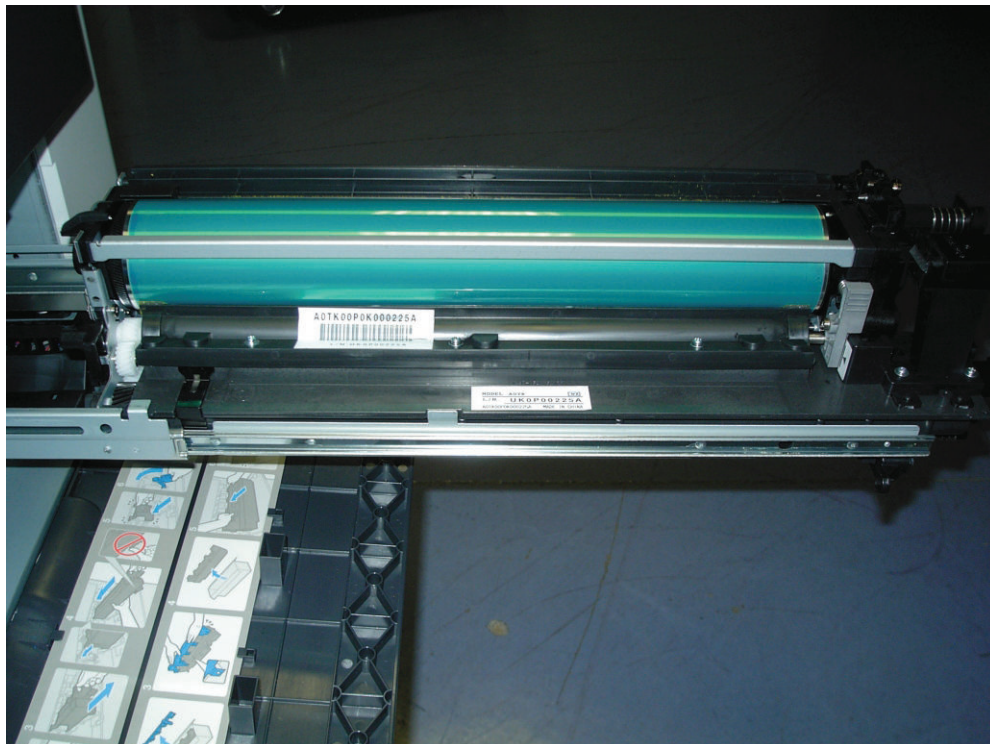
8. Job done. Now we need to install again the drum unit over the developer unit, reverse action from step 5.

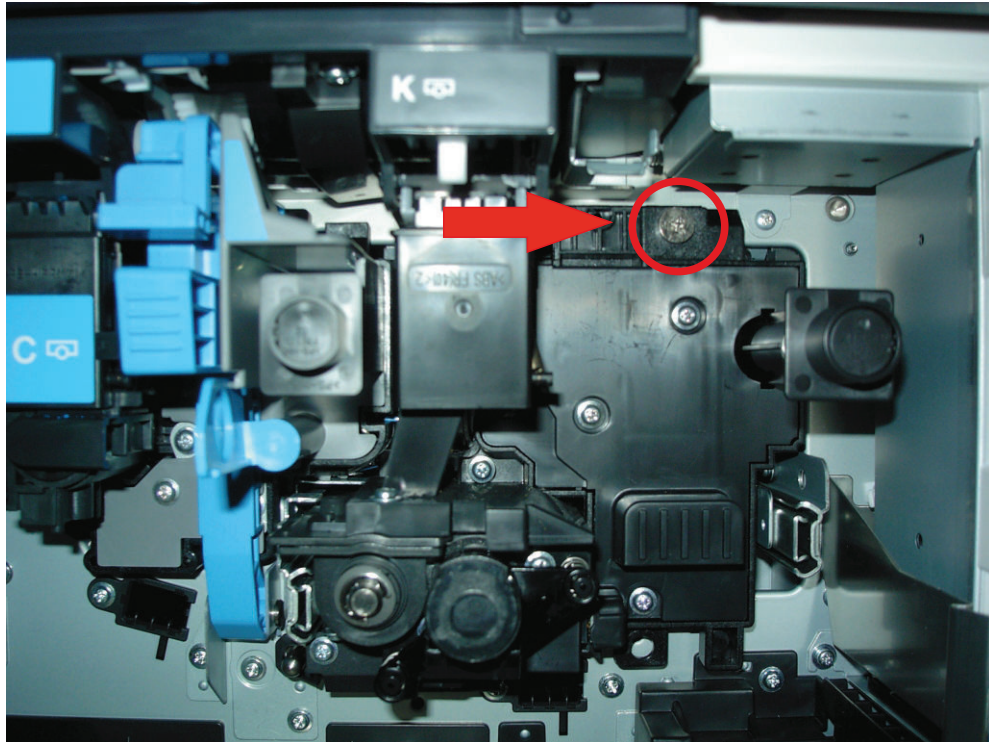
9. Ensure that it is properly fit, and push inside the machine again the black image unit till the end, then you can screw again it to the machine and then reinstall the waste toner box back by pressing inside strong until it get armed for end our work.

10. Close the front cover, wait until machine recognizes our new chip, will reset the full lifecycle and will make an stabilization process as a new drum unit installed.
